## Evaluation of Reclamation Activities on Post-Mining Land

*This study aims to evaluate reclamation activities on the post-mining land of PT Bumi Sentosa Jaya in Boedingi Village, Lasolo District, North Konawe Regency, Southeast Sulawesi Province. Mining activities carried out in the area have caused environmental degradation, particularly in soil quality and vegetation. Therefore, reclamation activities, including revegetation, need to be carried out to restore the ecological function of the land. This study uses the Normalized Difference Vegetation Index (NDVI) analysis method to evaluate the success rate of revegetation as an indicator of vegetation health and density. In addition, an analysis was conducted on the reclamation plan and the estimated costs required. The data used in this study consisted of Sentinel-2 satellite images and drone photos to obtain an accurate picture of topographical changes and vegetation growth. The results showed that the reclamation activities carried out by PT Bumi Sentosa Jaya succeeded in increasing vegetation density in the reclaimed area. The area of land that has been reclaimed reached 11.90 ha in the period from 2023 to 2024, with the suc

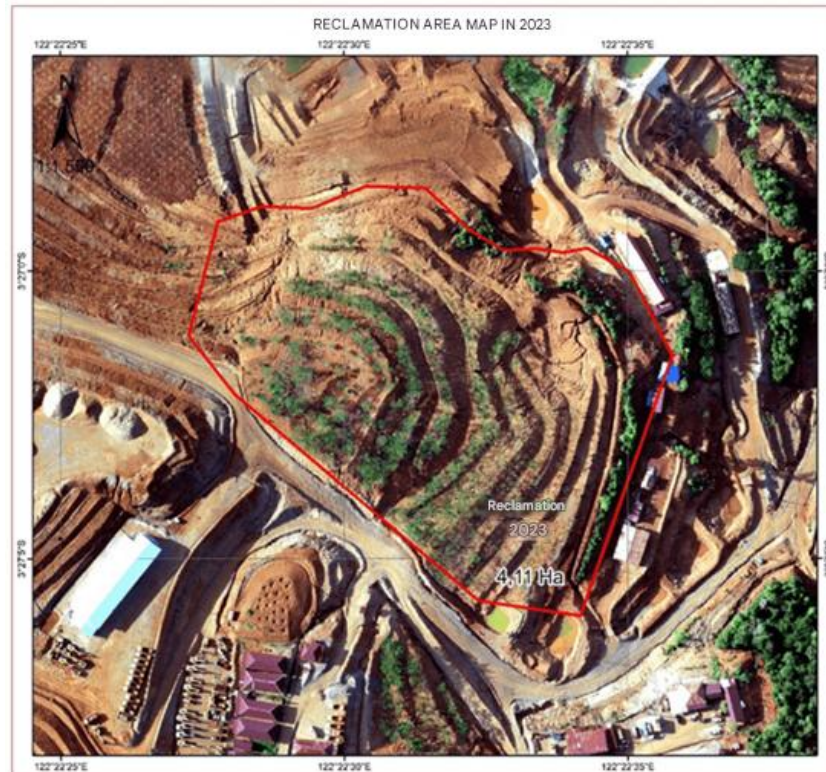
In 2023, reclamation activities will focus on revegetation, with a revegetation area of 4.11 hectares. This target area was established in accordance with the initial plan based on the reclamation plan document. This area was obtained from field measurement reports using DJI Phantom 4 drone photography technology and compared with satellite imagery.

Table 4. Reclamation Area Map 2023

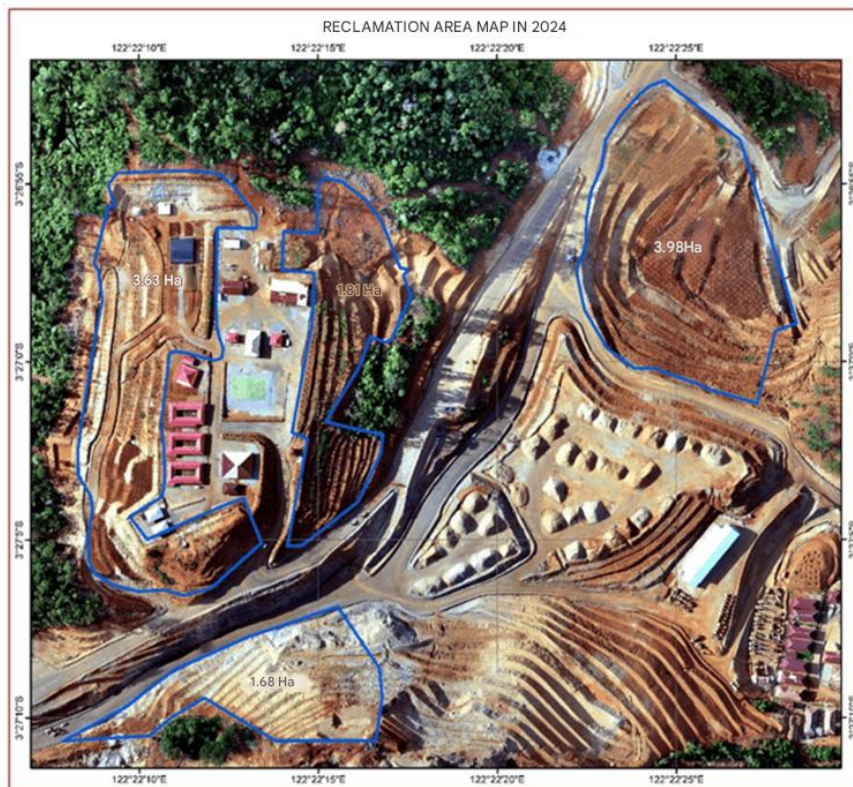
Figure 4. Reclamation Area Map in 2024

The target planting area for 2024 is 11.19 hectares, based on the reclamation plan. Based on available data, the reclamation area planning has been implemented effectively in accordance with the established objectives. The data obtained was derived from direct field measurements of the reclamation area, which were then correlated with the established reclamation plan. The following is Table 4 of the 2024 reclamation/revegetation plan:
